EXAMINATION OF A JAPANESE 140mm (5.5-INCH)
BOMBARDMENT PROJECTILE.

REPORT NO. 9-43. April 26, 1943.

NAVAL PROVING GROUND CAPTURED ENEMY EQUIPMENT
REPORT NO. 67.

To make a complete physical, chemical and metallurgical study of a Japanese 140mm (5.5 inch) Bombardment Projectile. (CEE527).

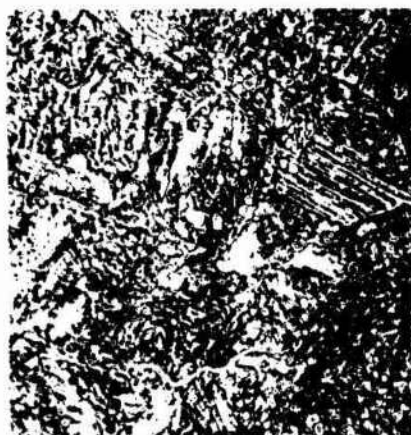
4A

PROJECTILE BODY Spheroidized
carbides and acicular ferrite.

MAGNIFICATION 1200X

MICROSTRUCTURE AND HARDNESS. The projectile body has a uniform hardness of 21 Rc, corresponding to a tensile strength of approximately 110,000 p.s.i.; the microstructure, shown in Fig. 4A, indicates that the steel has been cooled fairly rapidly from above the critical, but not sufficiently rapidly to affect complete hardening. Following this treatment a complete spheroidization was attained by a high temperature draw estimated to be between

1150 and 1250°F.
